Ceramic Applications in Turbine Engines

Harold E. Helms, Peter W. Heitman,
Leonard C. Lindgren, and Samuel R. Thrasher
Allison Gas Turbine Division
General Motors Corporation

October 1984

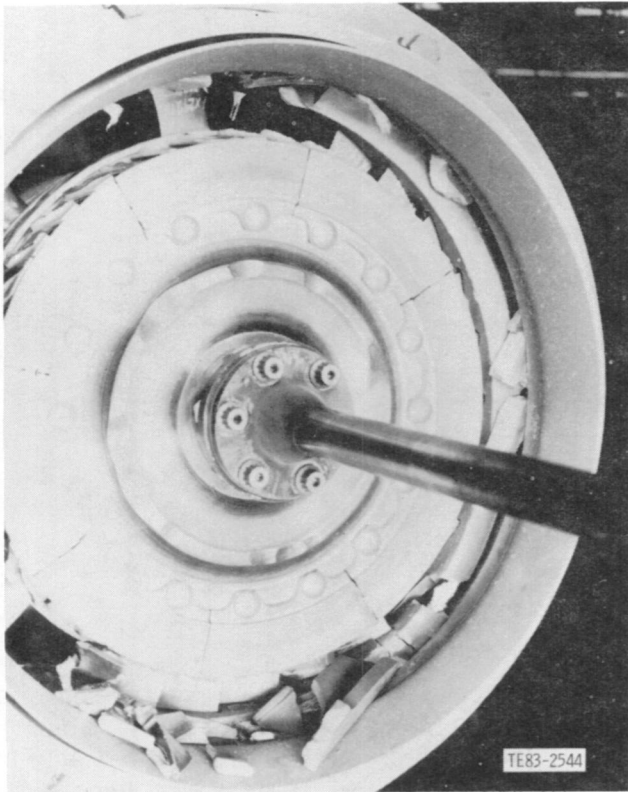
Figure 74. Gasifier turbine assembly, for engine C-4, TD14 (close-up view).

Upon removal of the gasifier nozzle assembly from the engine, some initial observations were made. Figures 73 and 74 show the gasifier section looking from the rear. Approximately half the nozzle section was missing and rotor airfoils were missing. No rub marks were seen on the outlet side of the gasifier turbine wheel.

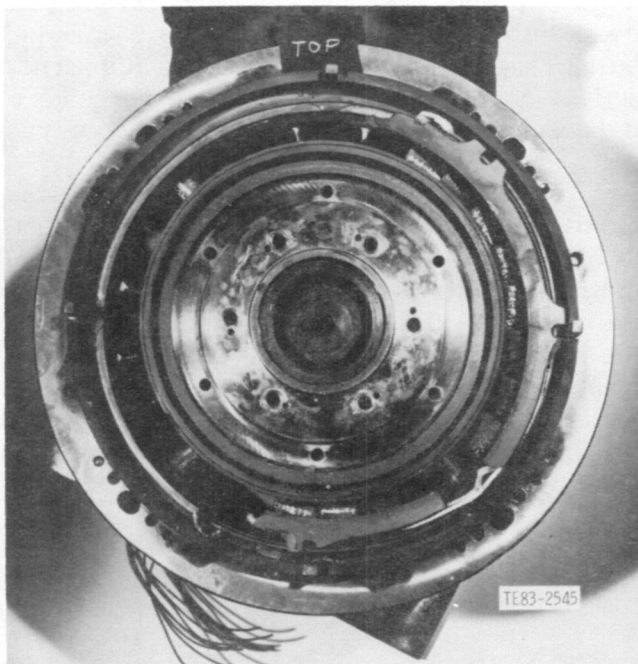
Figure 75. Gasifier nozzle assembly for engine C-4, TD14.

Figure 75 shows the nozzle assembly after removal of the gasifier turbine rotor. The following were noted:

1. Approximately one half the outer vane support ring was in place.
2. The inner vane ring was fractured (180 deg from top).
3. The inner vane support ring lip seal is locally chipped (225 deg).
4. High temperature cement (H cement) was missing from the strut shell rope seals. This is further illustrated in Figure 70. Cement debris could pass through the primary gas path.
5. Some thermal barrier material was missing from the plenum flow-path surface.

The locally chipped blade seal lip (see Figure 75) showed a contact origin at the i.d. of the lip; however, this could be the result of a blade release from an attachment failure.

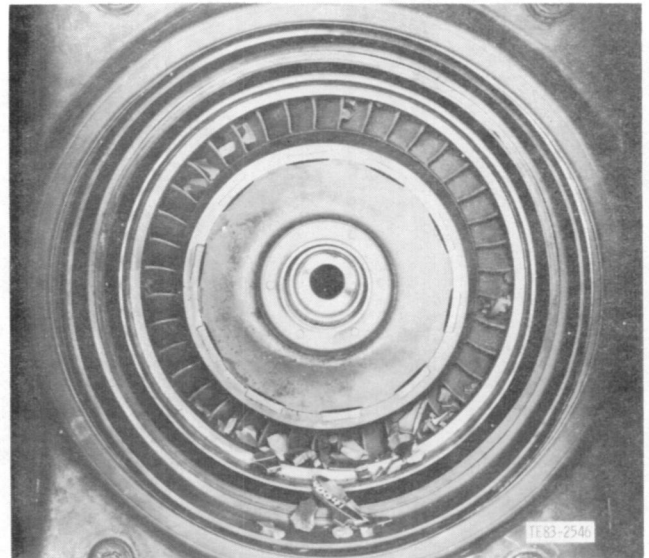
Figure 76. Inlet view, power turbine nozzle assembly for engine C-4, TD14.

Figure 76 is a view into the inlet of the power turbine nozzle. Large pieces of the vane outer support ring, vanes, and shroud are seen as indicative of the rapid 32-sec shutdown, and the gasifier tur-

bine blades were gone when these pieces passed through the gasifier rotor.

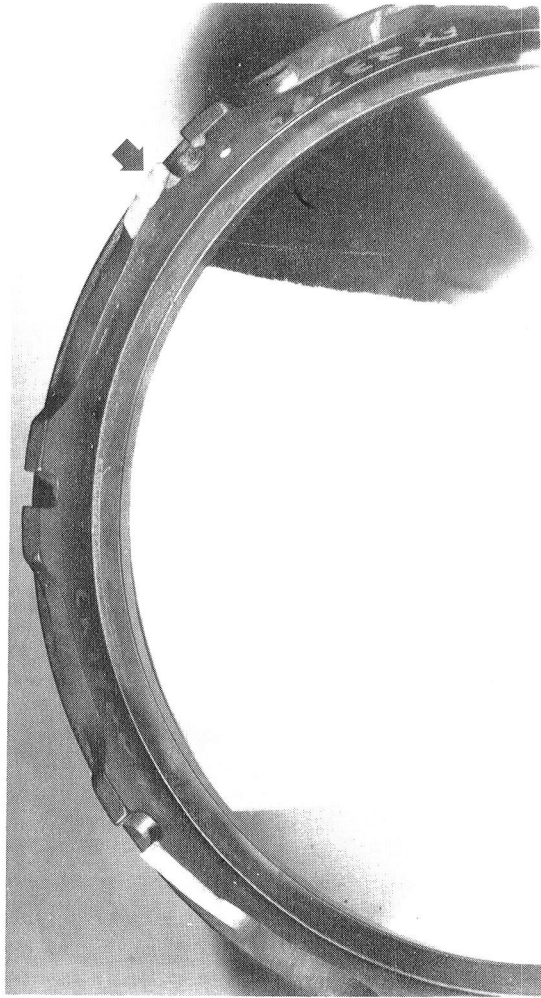
Figure 78. Chipped retention lugs inner vane support ring for engine C-4, TD14.

Figures 77 and 78 further illustrate the failed inner vane support ring. This ring is RBSiC material and had successfully accumulated 890 test hours in engine C-4 with a metal gasifier turbine rotor. Temperature was limited to 1038°C (1900°F). The chips in three of the ring retention lugs are consistent with prior test experience. A possible explanation is that fast fracture produces a recoil action which is reacted at the ring lugs and causes the chipping type failure. The ring fracture origin is near the maximum predicted stress location (see Figure 79). No heat tint was observed on the failed surface. The

Considering the impact nature of the failure origin with no evidence of heat tint, the IVSR failure was determined to be secondary.

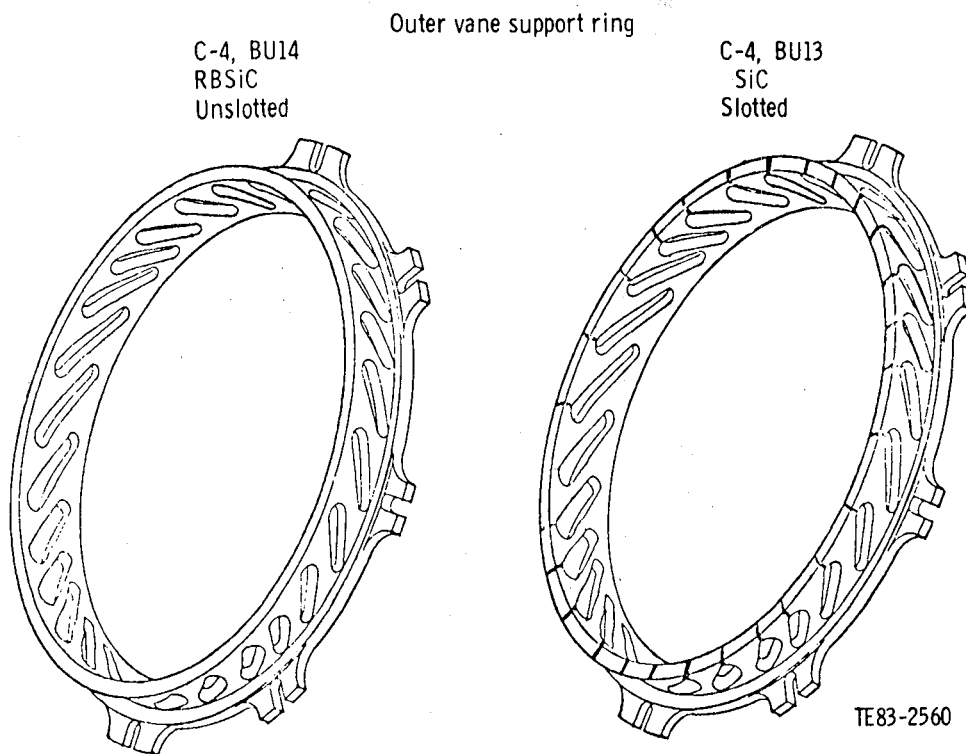
Figure 80. Outer vane support ring configuration for engine C-4, TD14.

Postfailure investigation of engine C-4/BU13 raised a concern for potential vibration of the slotted OVSR and subsequent failure. This concern was addressed in C-4/BU14 by configuring the engine with an unslotted ring. The rings are illustrated in Figure 80. The BU14 ring was a new, reaction-bonded SiC ring that had successfully passed the thermal shock

rig proof test. Failure analysis on the remaining pieces found all fracture origins to be due to impact. Primary failure of the OVSR was determined to be unlikely.

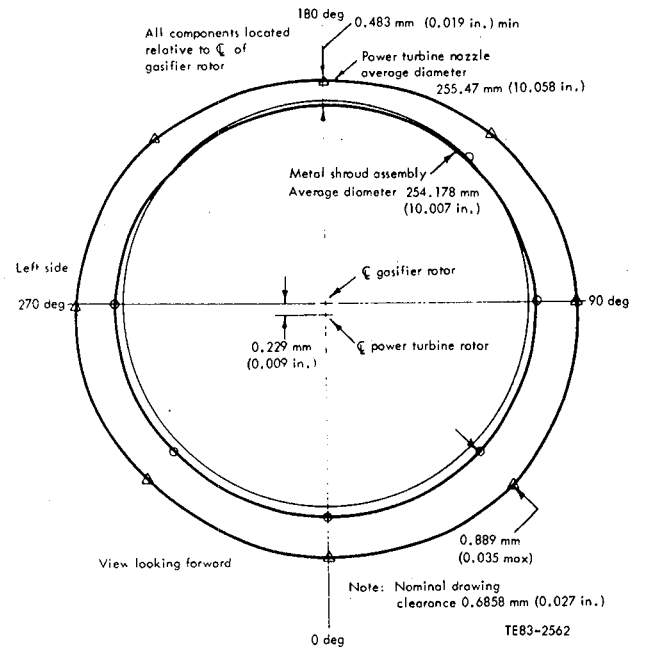
Figure 82. Engagement of the gasifier nozzle into the power turbine nozzle for engine C-4, TD14.

The diameter and runout relative to the centerline of the gasifier turbine at locations A, B, and C per Figure 81 were taken. These served to define the radial engagement of the gasifier nozzle into the power turbine nozzle. The results are shown in Figure 82. Note that the center of the power turbine nozzle is displaced 0.23 mm (0.009 in.) from the center of the gasifier nozzle. The piston ring seal accommodates this with no line-to-line contact.

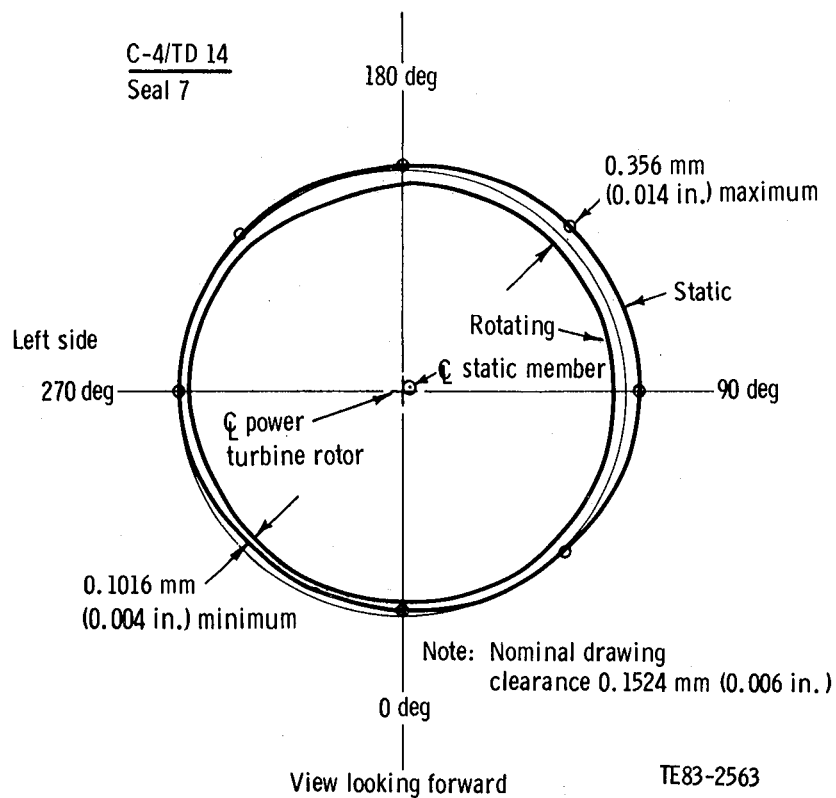
Figure 83. Engagement of labyrinth seal 7 for engine C-4, TD14.

The diameter and runout relative to the centerline of the power turbine rotor at seal 7 per Figure 81 were taken. The measurements are shown in Figure 83 and confirmed the build observation of a freely rotating power turbine. A complete picture of the centerline geometry of the gasifier/power turbine engagement is shown in Figure 84. The offsets are typical of the IGT engine. No witness marks were detected at teardown; thus it was concluded that forcible distortion of the ceramic nozzle by the power turbine nozzle/block was unlikely.

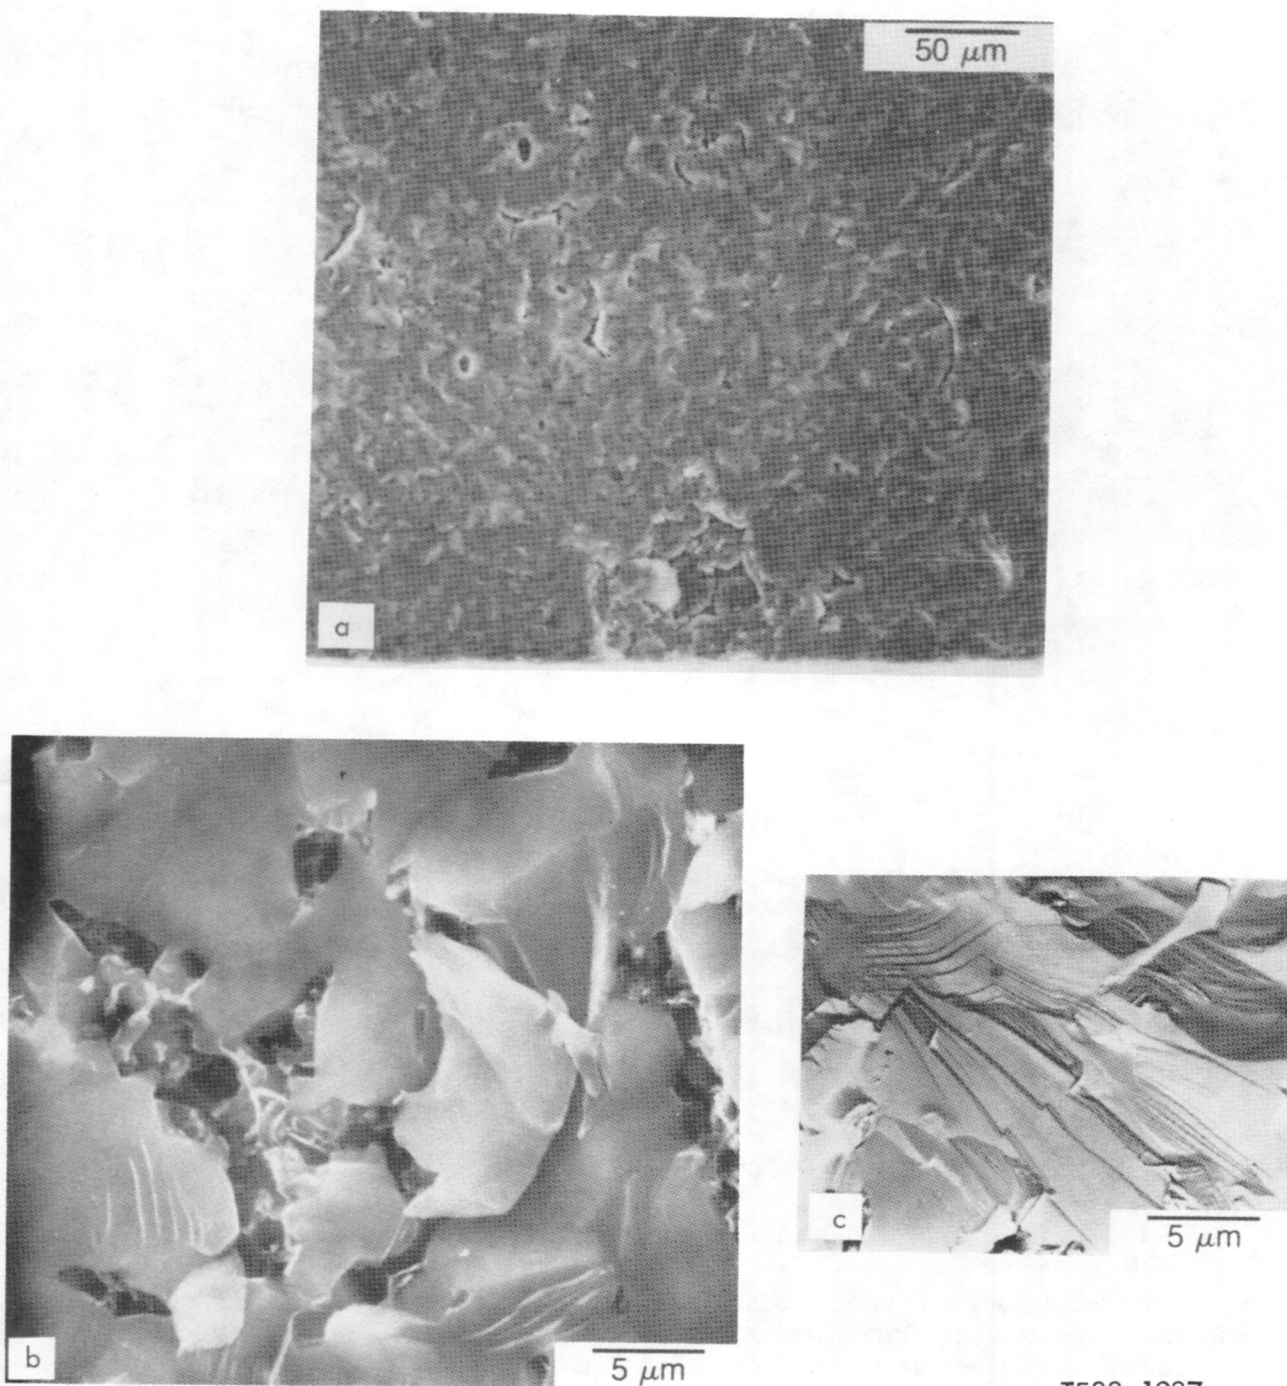
The room temperature MOR of longitudinally ground specimens averaged 335.72 MPa (48.69 ksi) with a standard deviation of 55.30 MPa (8.02 ksi). The primary strength-controlling defects were observed to be small pores and inclusions, shown in Figure 86. All fracture modes were observed to be transgranular cleavage.

Figure 86. Fracture surfaces of CBO sintered SiC test material: (a) surface pore and (b) and (c) transgranular cleavage.

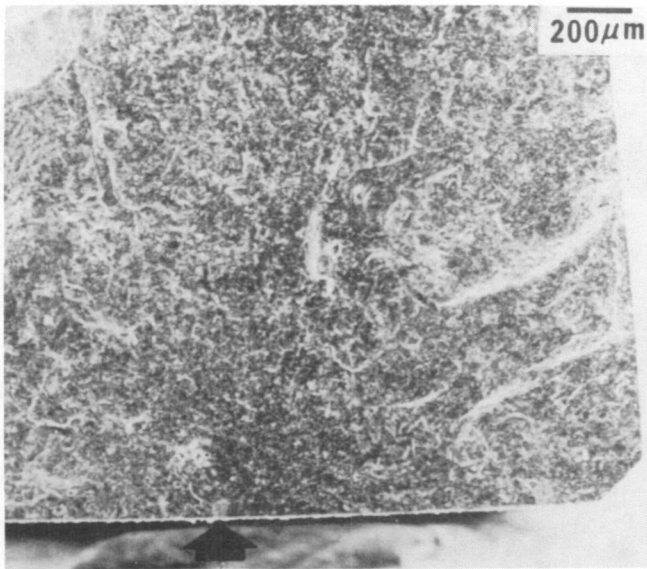
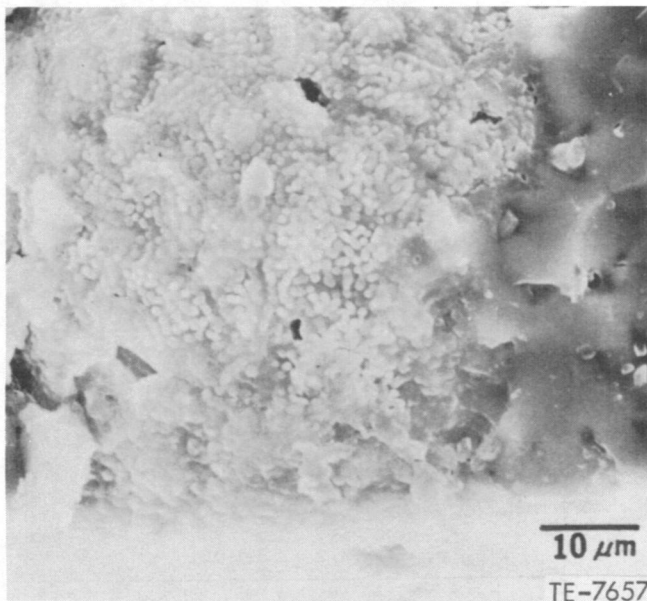
Oxidation of alpha silicon carbide modulus of rupture (MOR) bars at temperatures up to 1371°C (2500°F) did not significantly alter either the strength or the critical flaw population controlling fast fracture strength. Strength-controlling flaws were still the pores and ball inclusions. Figure 88 shows the fractography of an MOR bar oxidized at 1050°C (1922°F) for 1000 hr. Failure originated at the large ball inclusion located at the surface, which is surrounded with oxide.

Figure 88. SEM fractographs of oxidized CBO alpha SiC (1050°C [1922°F], 1000 hr); failure origin, indicated by the arrow, is a commonly observed spherical inclusion, but it is oxidized as viewed at higher magnification.

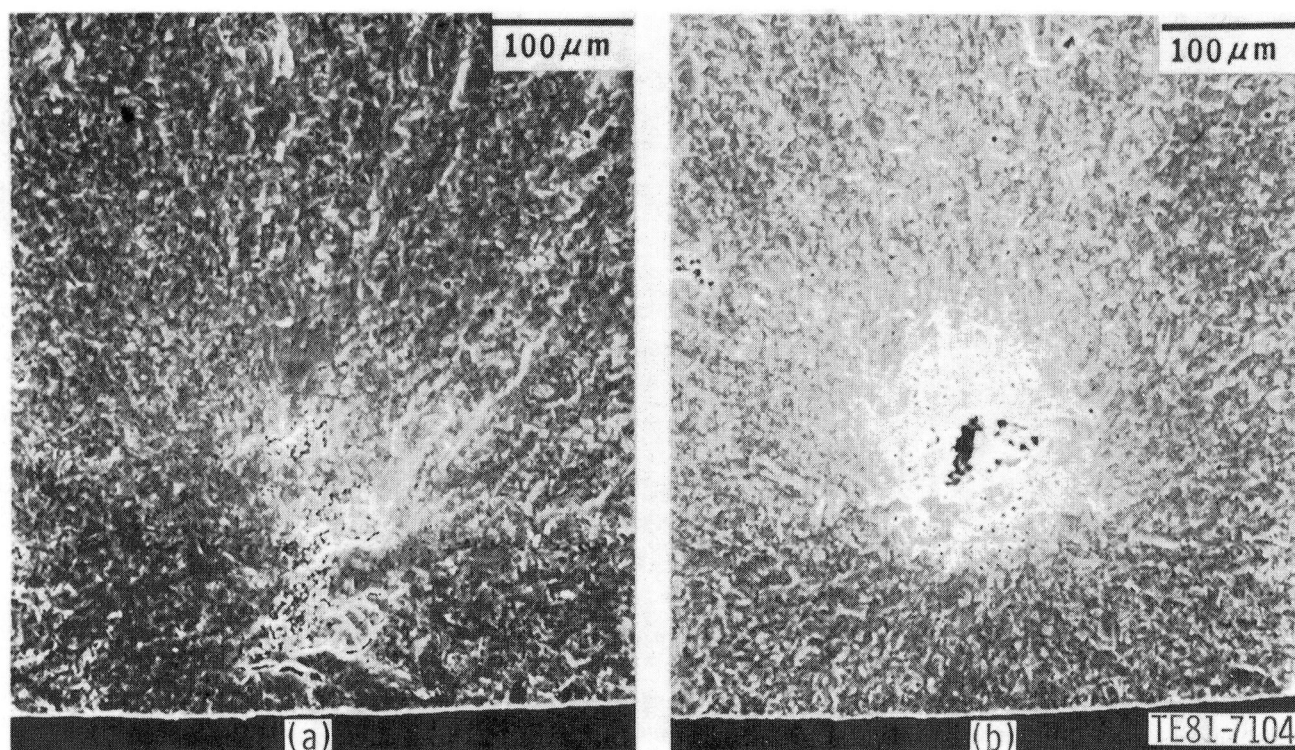
The average MOR of longitudinally ground bars tested at room temperature measured 328.31 MPa (47.62 ksi) with a standard deviation of 31.21 MPa (4.53 ksi). The primary strength-controlling defects observed in this material were found to be surface and internal pores. Figure 90 shows typical examples of a surface pore and an internal pore.

Figure 90. Typical fracture origins observed in Annawerk CD-100 sintered SiC: (a) surface pore and (b) internal pore.

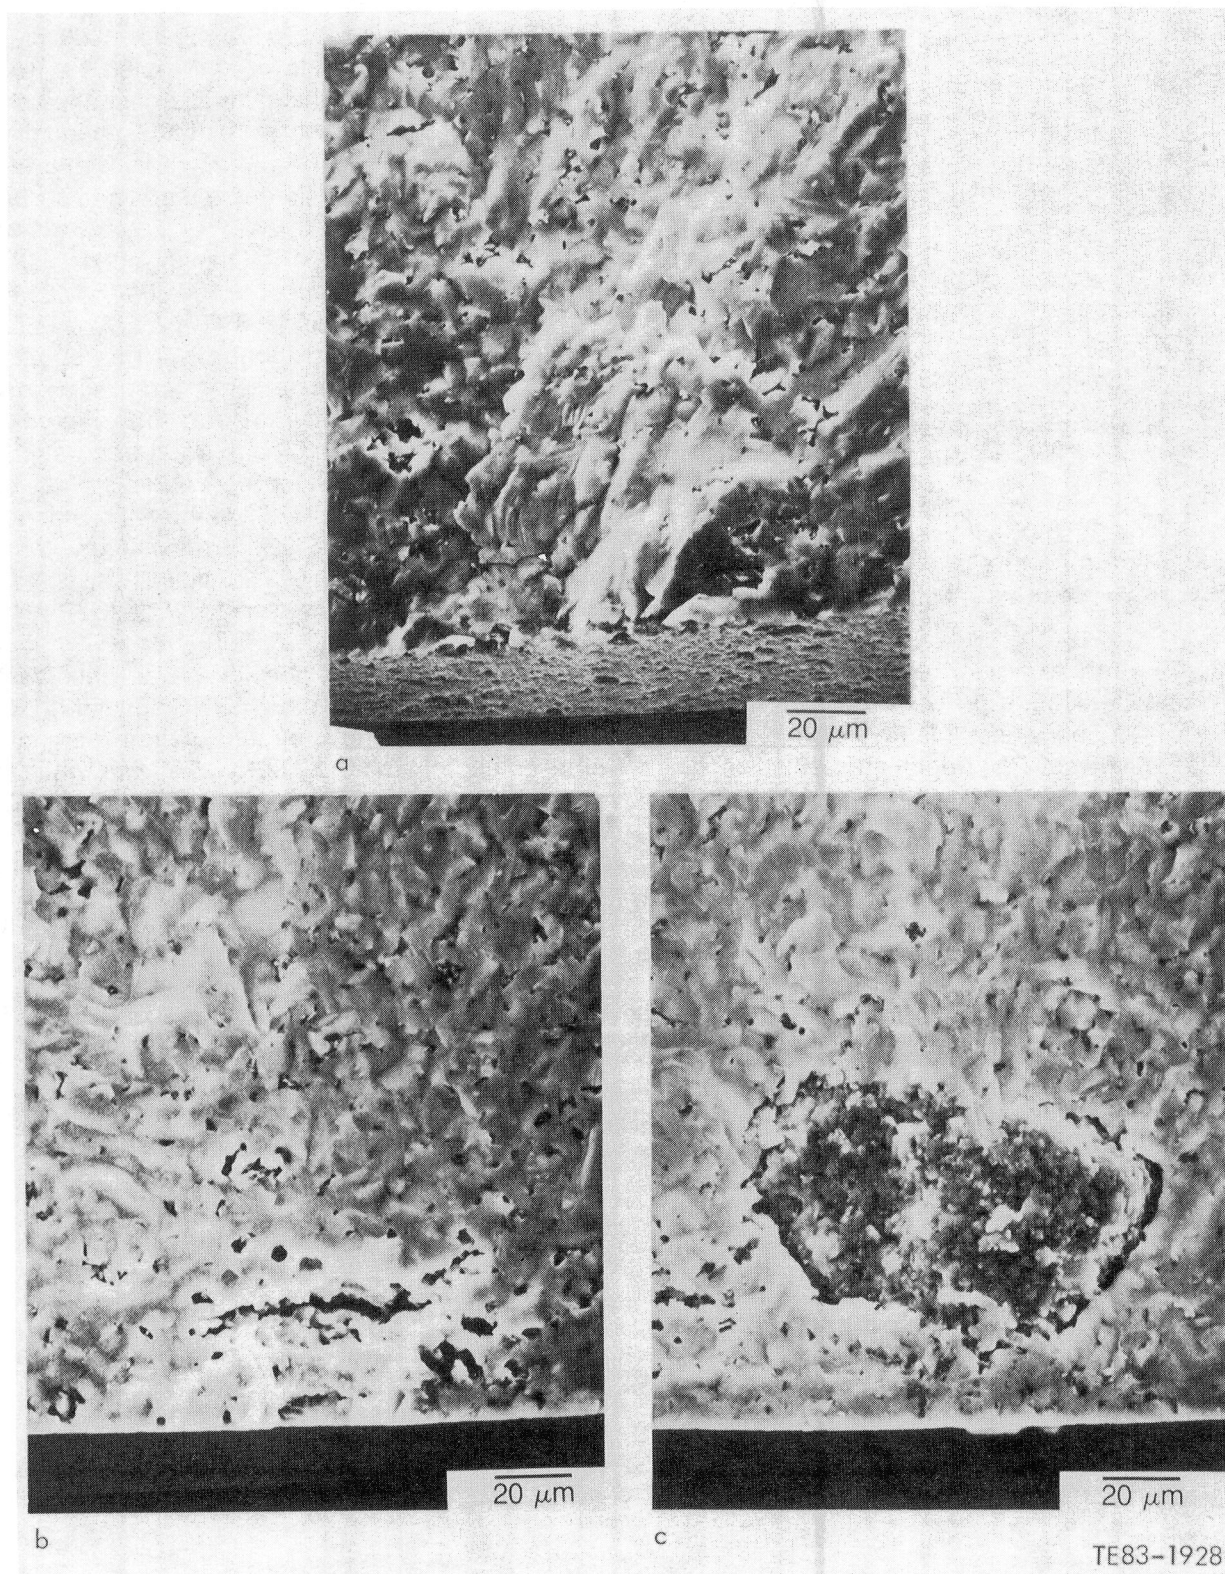
(45.93 ksi) with a standard deviation of 25.80 MPa (3.74 ksi). The primary strength-controlling flaws observed in these specimens, shown in Figure 92, were surface cracks (probably a result of the machining operation) with secondary flaws of surface and internal porosity.

Figure 92. Typical strength-controlling flaws observed in NGK Spark Plug EC-424 sintered SiC test bars: (a) surface crack, (b) surface pore, and (c) internal pore.

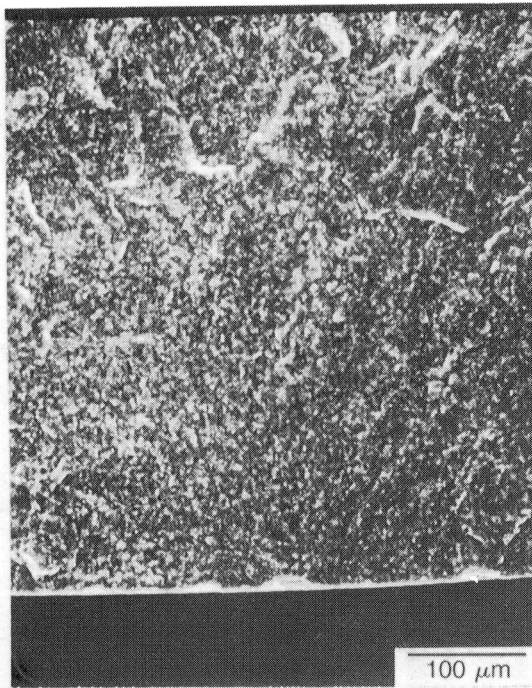
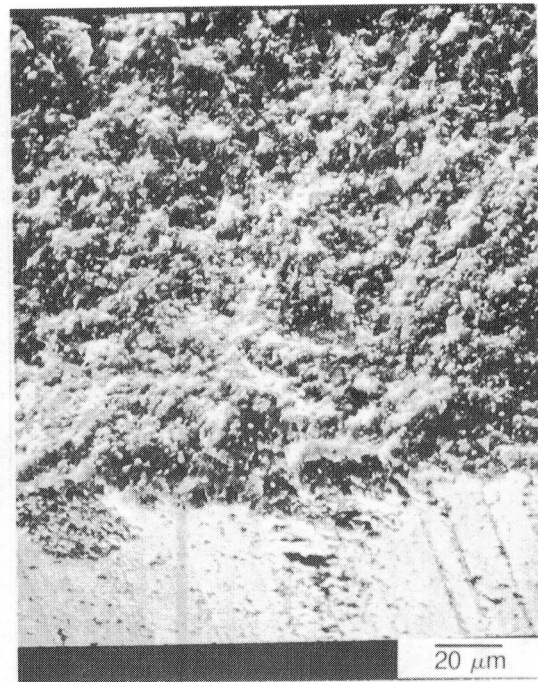
TE83-1933

pores (see Figure 95); (2) in bar No. 121.0078, a deep surface scratch running at an angle to the normal machining direction (see Figure 96); and (3) in bar No. 121.0090, a preexisting crack (see Figure 97). Excluding bars No. 121.0078 and No. 121.0090, which failed as a result of machining or handling damage, the average MOR of the longitudinally ground material was increased to 462.03 MPa (67.01 ksi) with a standard deviation of 82.81 MPa (12.01 ksi).

Figure 95. Failure origin (pore cluster) observed in longitudinally ground CBO KX-02 test bar No. 121.0069.

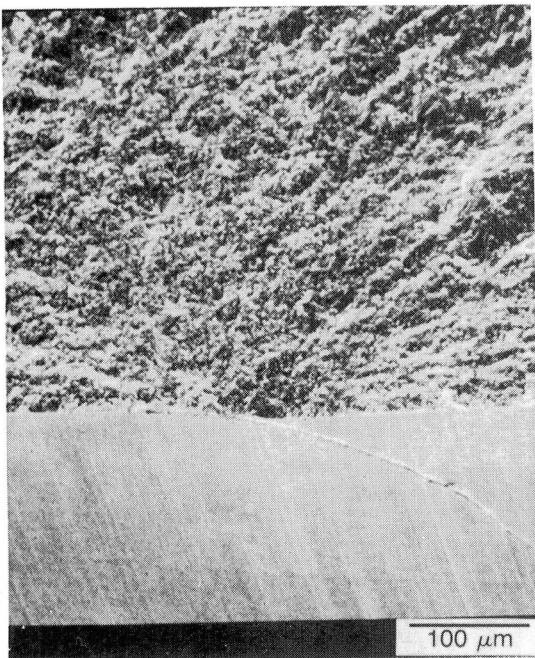
TE83-1934

Figure 96. Failure origin (surface scratch) observed in longitudinally ground CBO KX-02 test bar No. 121.0078.

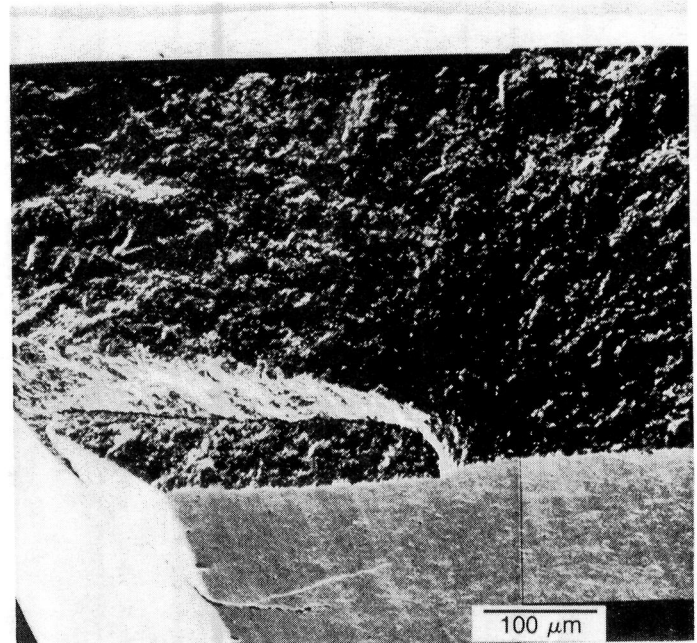
TE83-1935

Figure 97. Failure origin (preexisting crack) observed in longitudinally ground CBO KX-02 test bar No. 121.0090.

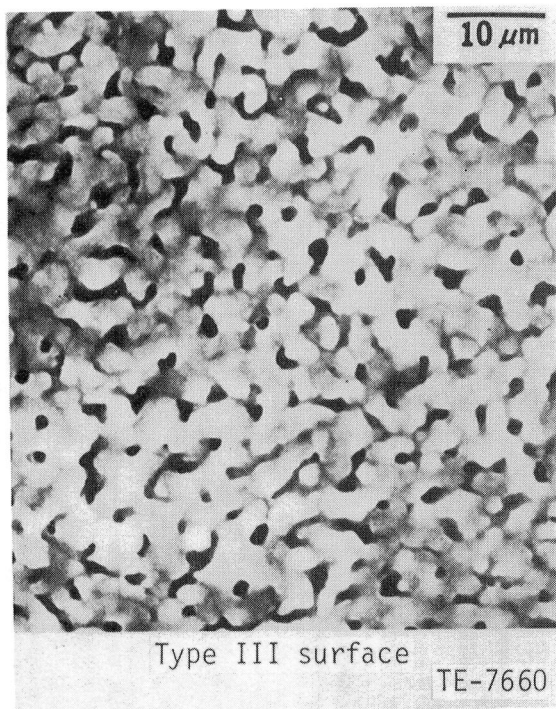
had traces of aluminum present, as shown in Figure 100. Exposure at 1050°C (1922°F) for 1000 hr produced a uniform oxide layer and tripled the weight gain. Microscopically, the general appearance of the oxide surface shows a network of nonsealing granular oxide, as shown in Figure 101. The average strength of both the as-fired and machined surfaces increased to 194.92 MPa (28.27 ksi) and 251.32 MPa (36.45 ksi), respectively, after 100 hr and 190.44 MPa (27.62 ksi) and 273.66 MPa (39.69 ksi) after 1000 hr.

Figure 101. SEM micrograph of machined surface of NC-430 oxidized at 1050°C (1922°F) for 1000 hr.

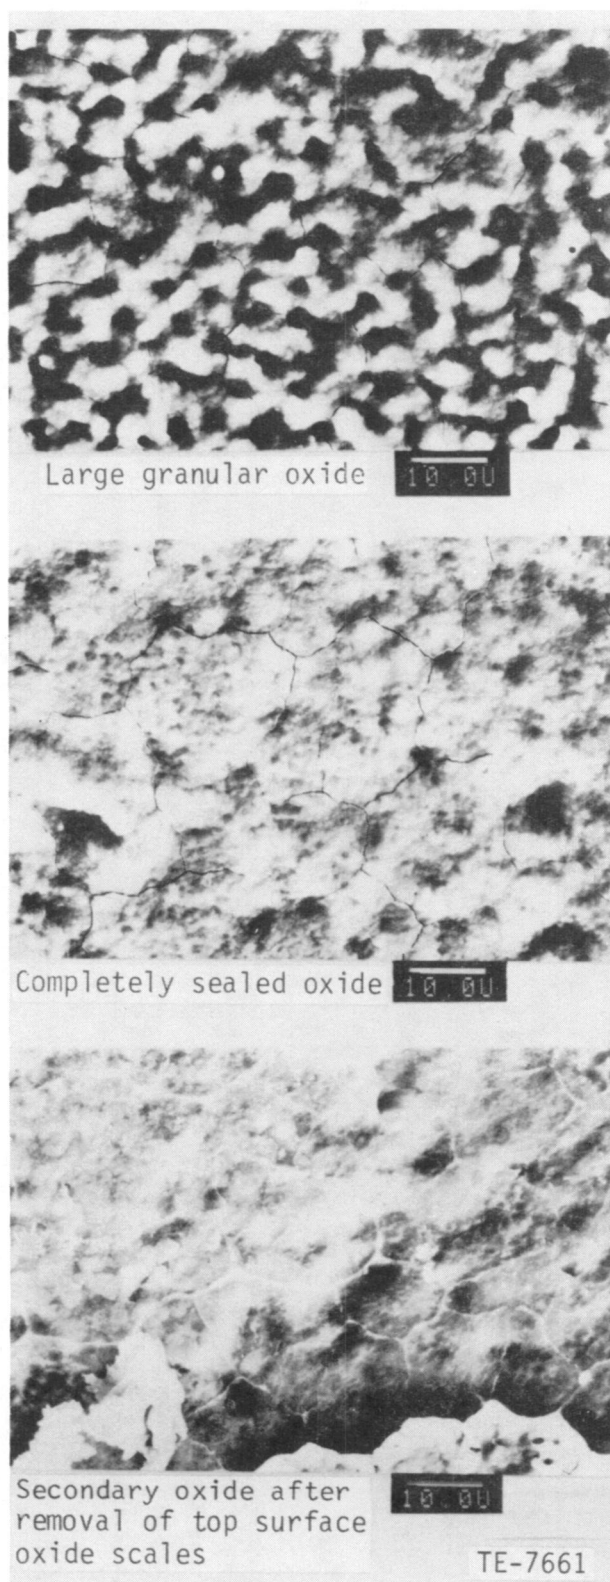
NC-430 oxidized at 1250°C (2282°F) exhibited similar but increased oxidation, with a completely sealed oxide layer (with numerous cracks) observed on the machined surface, as shown in Figure 102. Exposure for 100 hr resulted in an average strength of 222.16 MPa (32.22 ksi) for the as-fired surface condition and 257.53 MPa (37.35 ksi) for the machined surface condition. After 1000 hr, the as-fired strength decreased slightly to 194.03 MPa (28.14 ksi) while the machined strength increased to 284.63 MPa (41.28 ksi).

Figure 102. SEM micrograph of machined surface of NC-430 oxidized at 1250°C (2282°F) for 1000 hr.

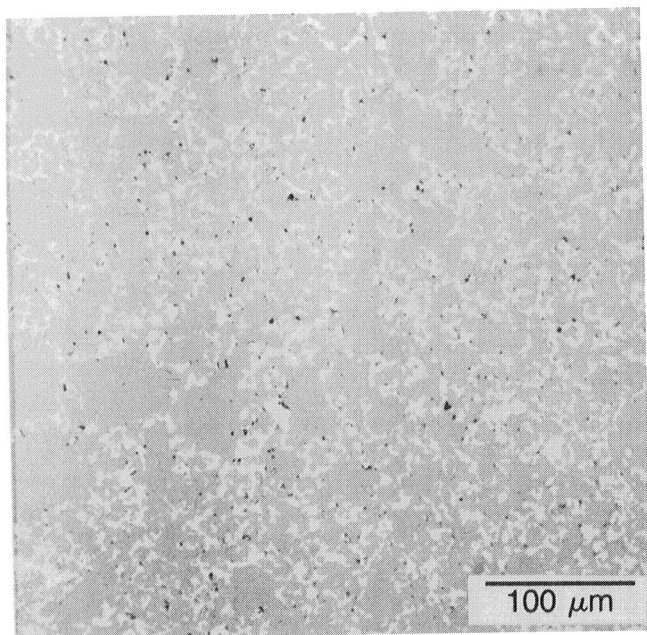
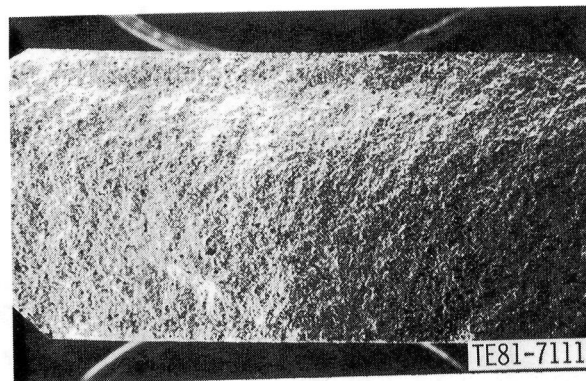
with a standard deviation of 10.20 MPa (1.48 ksi), for the as-fired surface condition and 299.71 MPa (43.47 ksi), with a standard deviation of 22.82 MPa (3.31 ksi), for the machined surface condition. In all cases, surface sites were identified as the locations of the failure origins. A typical fracture surface is shown in Figure 105.

Figure 105. Typical fracture surface of Norton NC-433 RBSiC test bar.

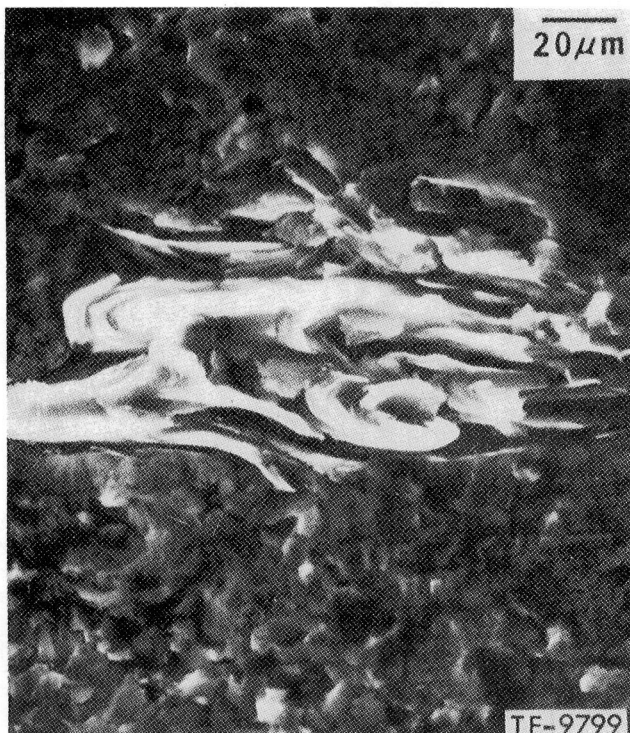
The average strength of the machined surface condition was similar for both materials (no difference exists at a 0.05 significance level). The slip cast material failed exclusively from surface sites, presumably from machining flaws, since no unusual microstructural feature could, in general, be associated with a given origin. However, in the case of the extruded material, failure originated at both surface and subsurface sites. Surface failures were associated with machining defects; the subsurface failures originated from carbon particles. A typical

example of a subsurface origin is shown in Figure 109.

Figure 109. Fracture surface of machined, extruded Pure Carbon Refel RBSiC, showing a carbon particle at the failure origin.

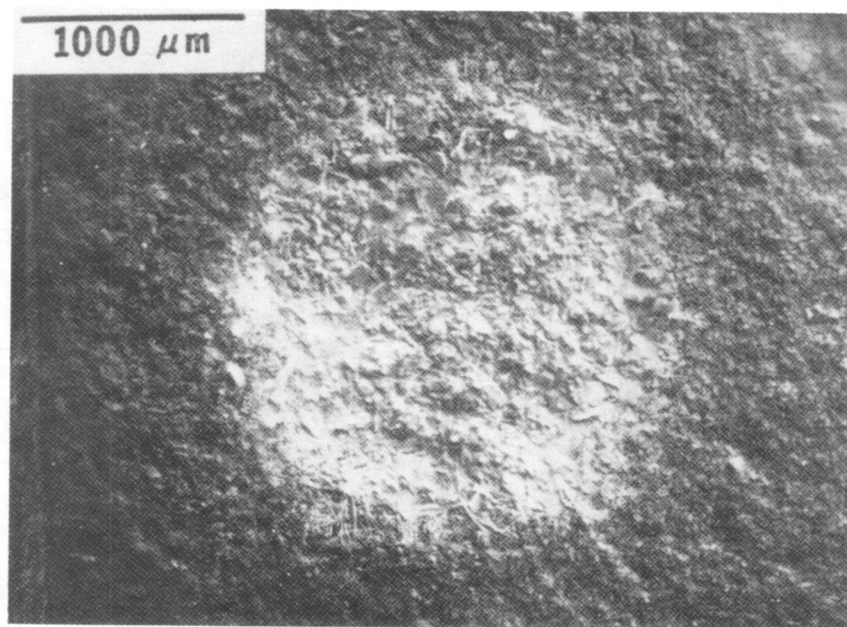
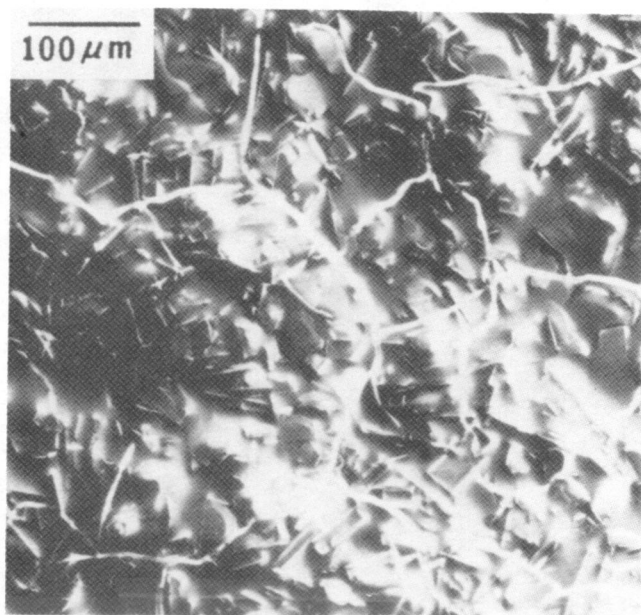
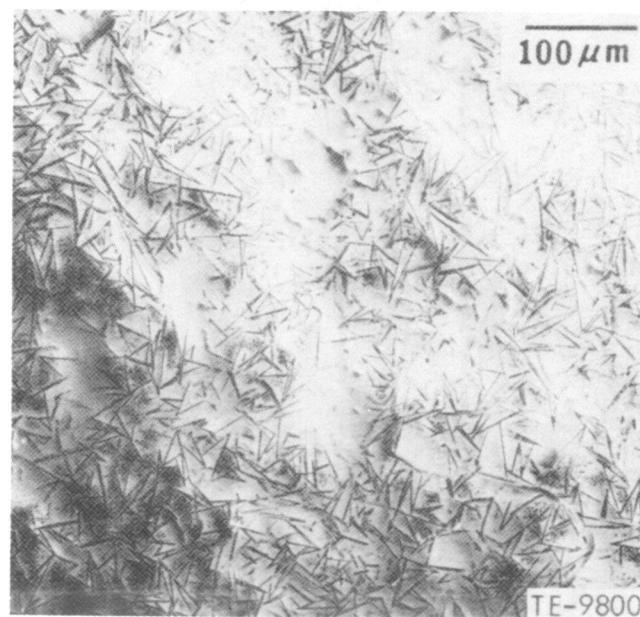
After exposure, the surface of the as-fired slip-cast material was covered by a crazed glass. Very large circular spots, approximately 2 mm (0.078 in.) in diameter, were visible, as shown in Figure 110. The oxide layer, in addition to containing silicon and oxygen, contains barium, calcium, and aluminum. An acicular phase, which is free of barium, was distributed throughout the oxide. The large glassy puddles

Figure 110. As-fired surface structure of slip-cast Pure Carbon Refel RBSiC after exposure at 1250°C (2282°F) for 100 hr.

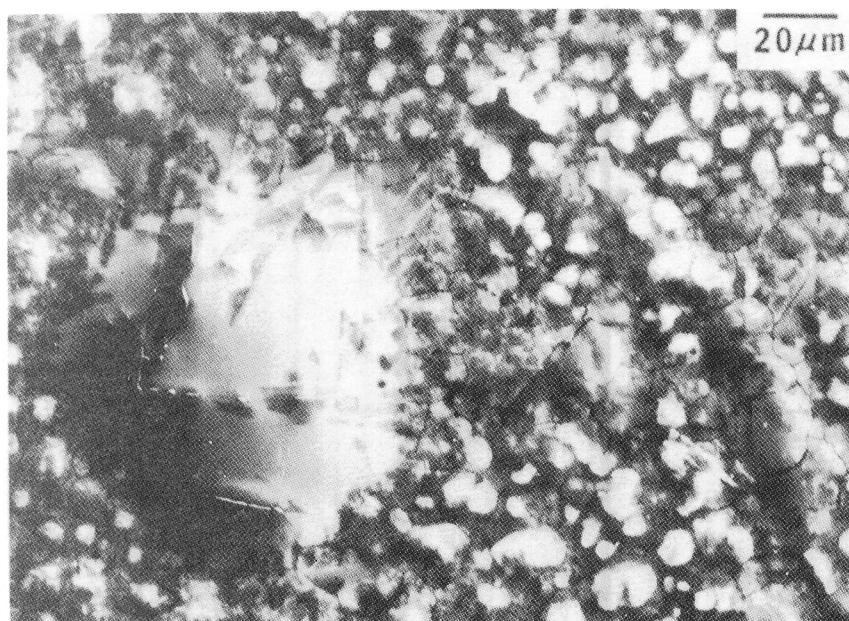
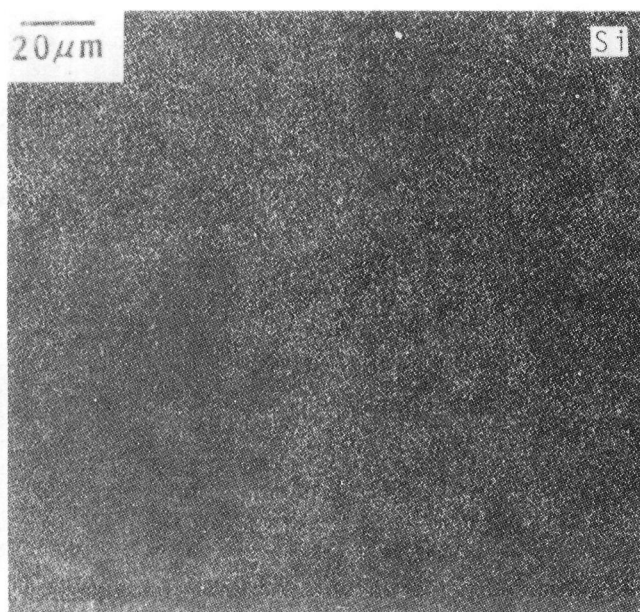
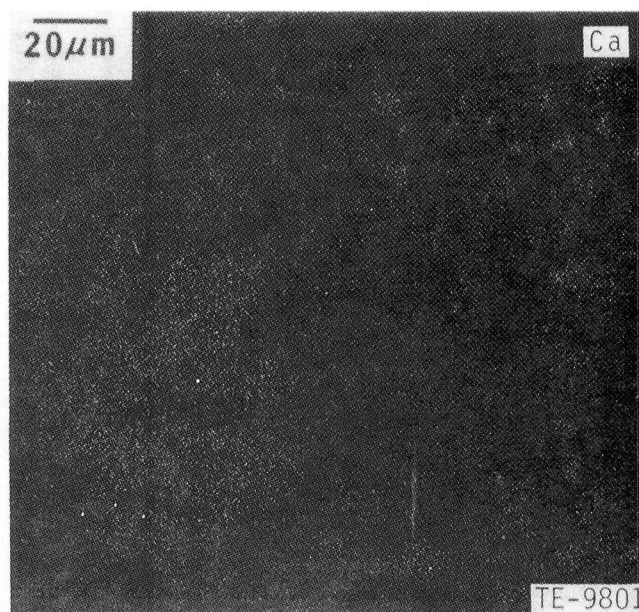
The machined and oxidized slip-cast material was covered with a crazed oxide with numerous hills and bumps, as shown in Figure 111. These bumps

Figure 111. Machined surface structure of slip-cast Pure Carbon Refel RBSiC after exposure at 1250°C (2282°F) for 100 hr.

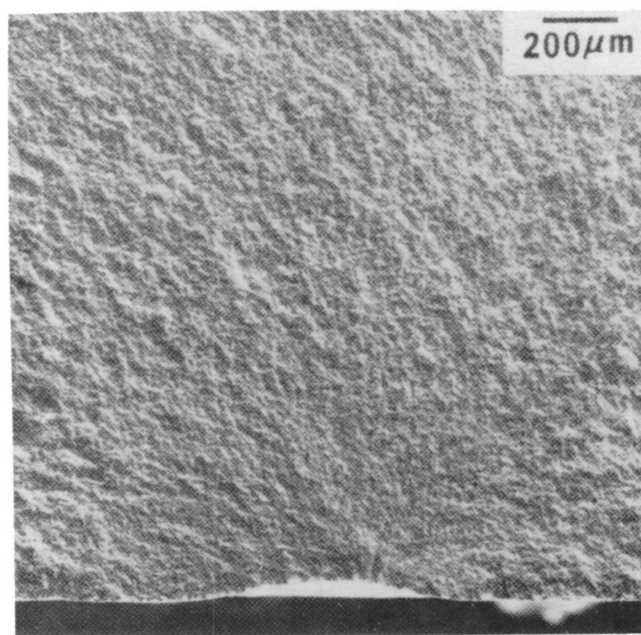
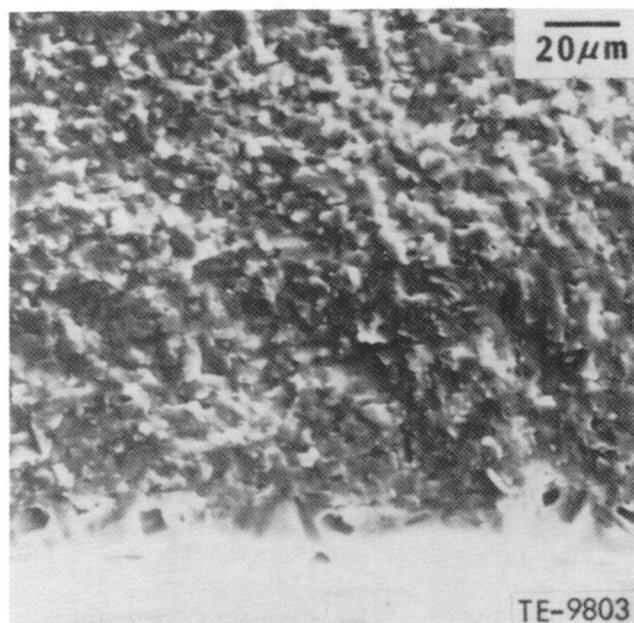
Figure 113. Fracture surface of slip-cast, Pure Carbon Refel RBSiC after oxidation showing glassy puddle at failure origin.

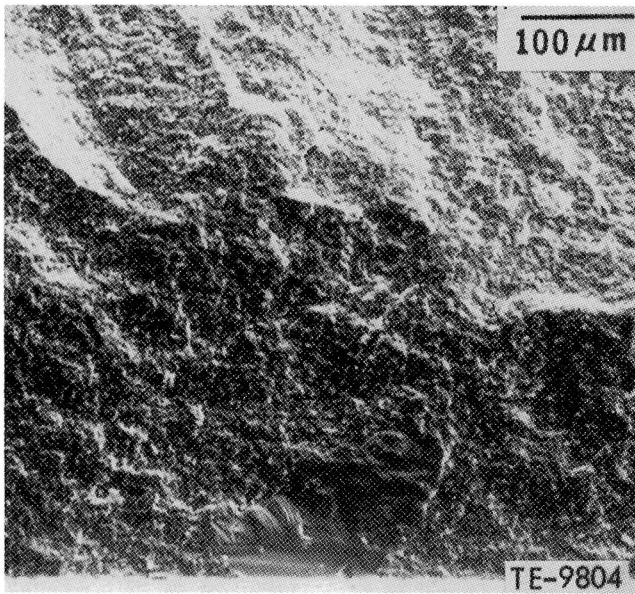
Figure 114. Photomicrograph of fracture surface of oxidized slip-cast Pure Carbon Refel RBSiC showing large grain at failure origin.

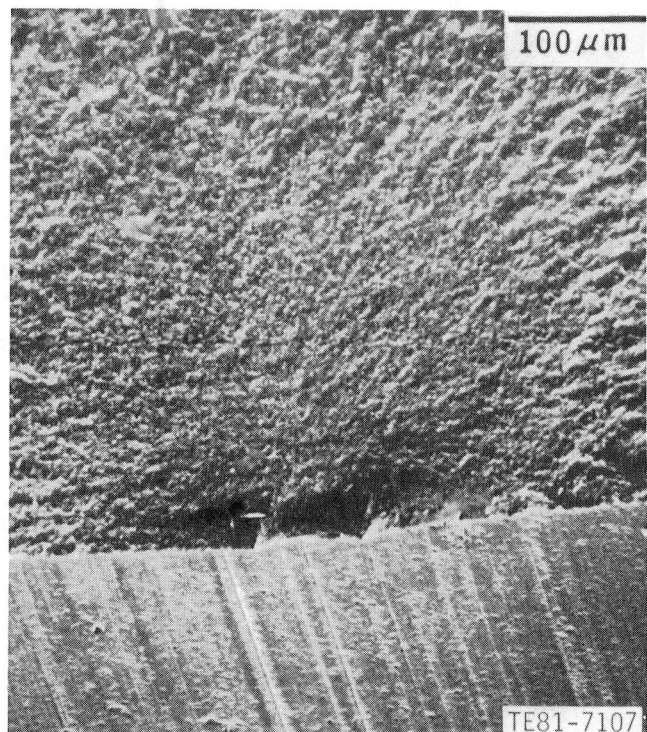
and surface flaws. Large surface cracks, such as the one shown in Figure 116, were frequently observed in the machined test specimens. The bar in Figure 116 registered a strength of only 303.80 MPa (44.07 ksi).

Figure 116. Typical example of failure origin (surface defect) observed in machined Kyocera SC-410 RBSiC test bars.

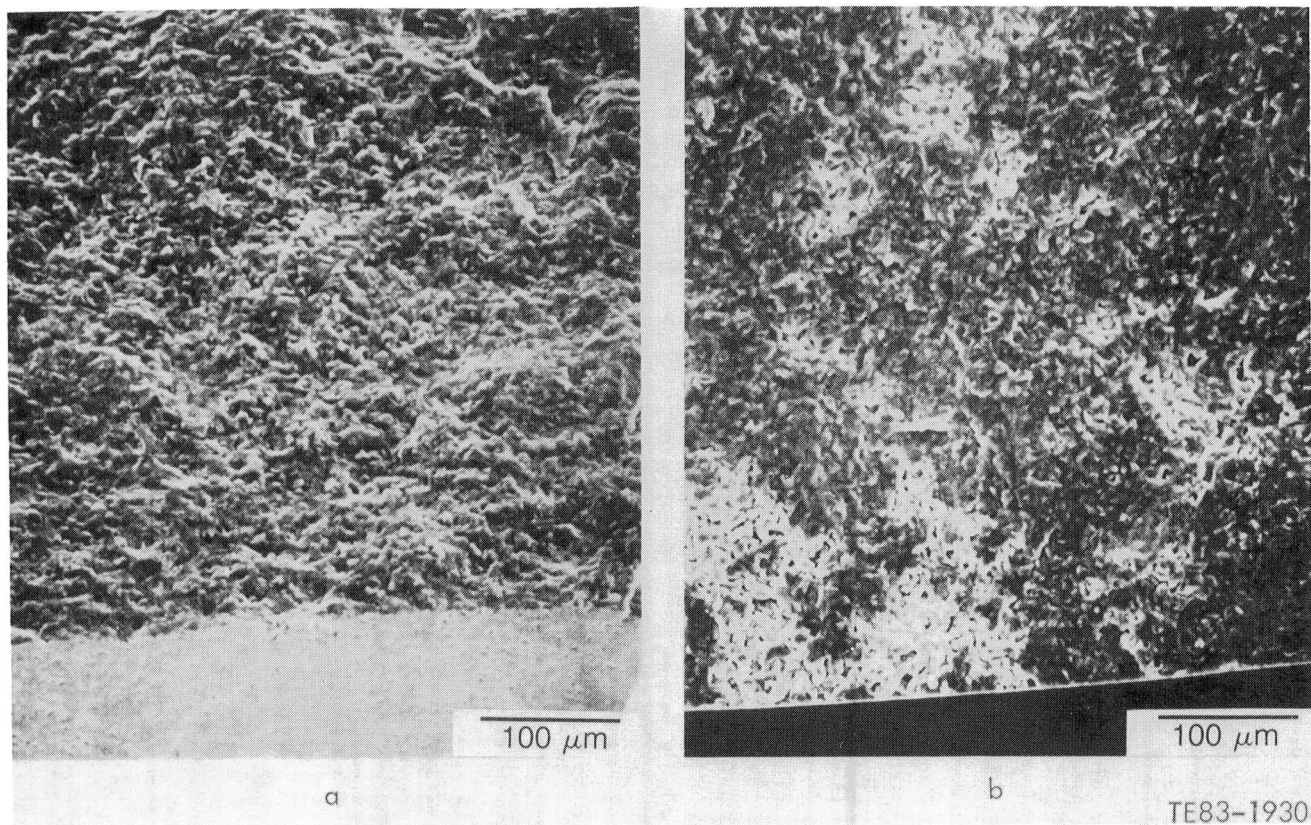
(38.17 ksi) with a standard deviation of 30.86 MPa (4.48 ksi). This strength level is considerably lower than the 500.00 MPa (72.52 ksi) published by NGK Spark Plug. The primary strength-controlling flaws in EC-414 material were surface cracks and pores, shown in Figure 118.

Figure 118. Typical strength-controlling defects observed in NGK Spark Plug EC-414 RBSiC test bars: (a) surface crack and (b) surface pore.
